YEAR/MODEL ANNÉE/MODÈLE	DATE OF ISSUE DATE EN VIGUEUR	BULLETIN NUMBER NUMÉRO DU BULLETIN
1993~1995 DEL SOL	JAN. 13/1995	IV-1-95

BURNED ~OUT AUXILIARY LIGHT

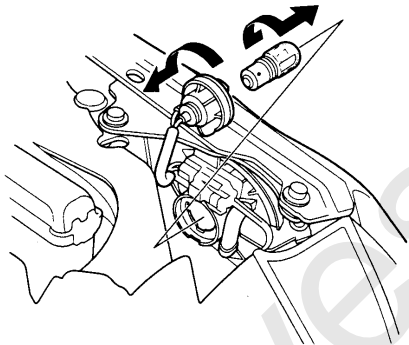
Some owners of 1993~1995 Civic Del Sol's may complain of one or both auxiliary lights burning out prematurely. To correct this problem replace the bulbs in both auxiliary lights (even if only one is burned out) with the improved bulbs, listed in Parts Information.

1. Open the hood.
2. Remove the socket from the lamp by turning it one-eighth turn counterclockwise.
3. Remove the bulb from the socket and install the new bulb.
4. Reinstall the socket in the lamp.
5. Repeat steps 2 through 5 on the other auxiliary light
6. Test the bulbs by turning on the headlights (low beam) and the auxiliary lights.
